Cold Expansion Tests for Plates Containing Elongated Holes

M. Heller, R. L. Evans and R. B. Allan DSTO-TN-0233

Airframes and Engines Division Aeronautical and Maritime Research Laboratory

October 1999

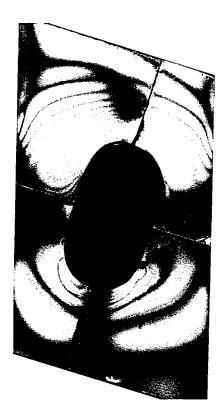
Figure 14. Photoelastic strain distribution at the maximum cold-expansion level for Specimen 1.

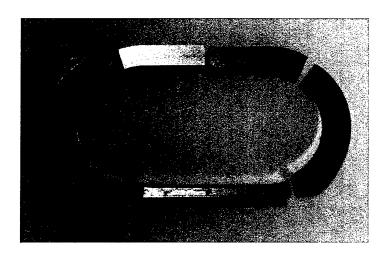
During the cold-expansion procedure, marked cracking sounds were heard during both plug insertion and removal. This was believed to be due to cracking of the sleeve and/or plug. Upon completion of the test it was found that the sleeve had split radially in five places as shown in Figure 15. Here it should be noted that the top, middle slit was the pre-exiting machined split in the sleeve. Additional circumferential cracking also existed around the inside of the sleeve, extending through the thickness at the lefthand end as shown in Figure 15. The plug also experienced some cracking, however it was still intact. As there were no replacement plugs the same plug was used in the cold-expansion testing of Specimens 2 and 3.

Figure 15. D2 sleeve of Specimen 1 after cold-expansion test completion, showing multiple fractures (original manufactured slit is at top centre).

sleeves have been identified, in that they were not significantly damaged during the expansion process, whereas the D2 sleeve was susceptible to cracking. Cracking of the plug was also evident and this was attributed primarily to the poor surface finish at the bore holes in the plug. Hence in future it is recommended that these holes are manufactured with an improved surface finish.

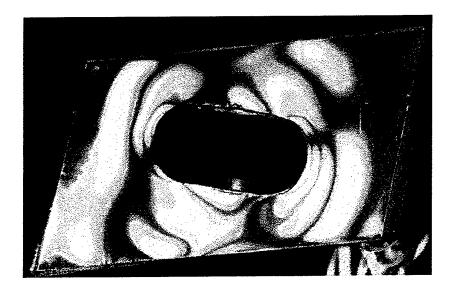
Figure 18. Photoelastic strain distribution at maximum interference-fitting level for Specimen 1.

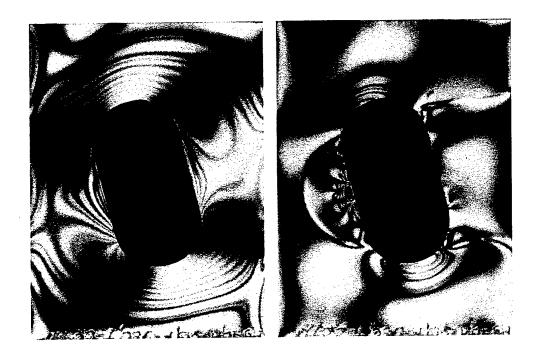
The photoelastic results are presented in Figure 20 for following two loading conditions, (i) at maximum cold expansion (left), and (ii) after the removal of the cold-expansion plug and sleeve (right). Since the photoelastic coating was damaged during the removal process, some anomalous fringe patterns along the flat sides of the hole are evident. However, it is clear that the strain distribution at maximum cold expansion level has been fully developed and is comparable to that obtained for Specimen 1 with the D2 sleeve. A well formed residual strain field around the end radii of the hole is also shown to exist after the cold-expansion process. Examination of the sleeve after cold expansion showed the presence of small cracks, as given in Figure 21. On removal

Figure 20. Photoelastic strain distributions for Specimen 2 at maximum cold expansion (left) and after cold expansion (right).
